Parcel C Remedial Action Project Update for Parcel C Hunters Point Naval Shipyard San Francisco, California

Tony Konzen
Project Manager
Contracted Support to NAVFAC BRAC PMO

BCT Meeting January 23, 2013

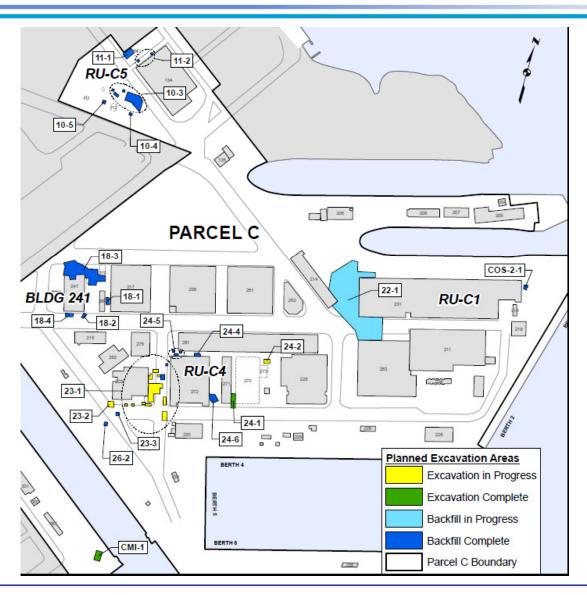
Parcel C Excavation Progress

As of Jan 10, approximately 25,100 bcy have been excavated and stockpiled. Approximately 26,000 bcy estimated to be removed as part of Parcel C Remedial Action.

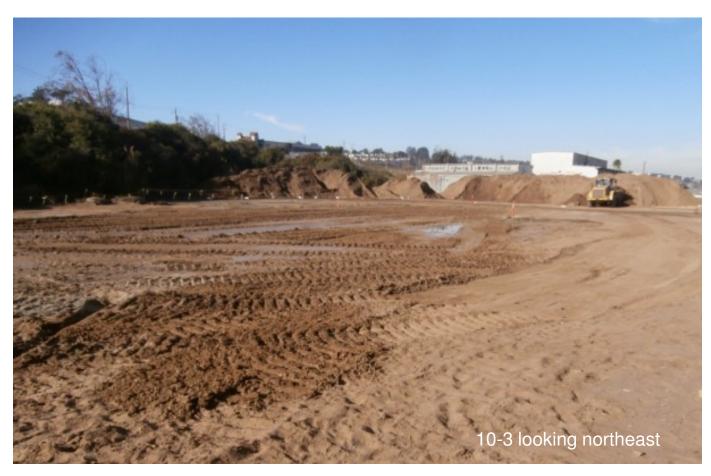
RU-C5 Summary

• Excavations10-3, 10-4,10-5, 11-2 were backfilled to grade in November. Area will undergo final compaction and grading this week.

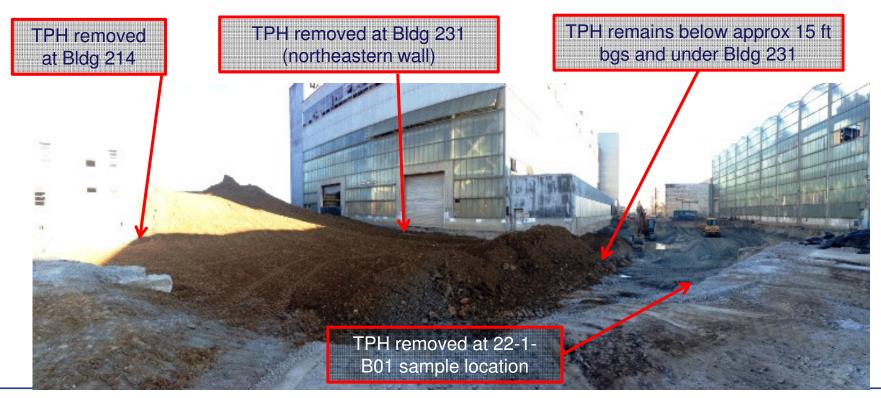
RU-C1 Summary (22-1)

- Excavation 22-1- Removal of CERCLA COCs completed. Backfilling with bridging material and clean fill to access step out locations is in progress.
- Oily material at corner of Bldg 214 and 231 were addressed in January. Further TPH over-excavation along the edge of Building 231 is underway.

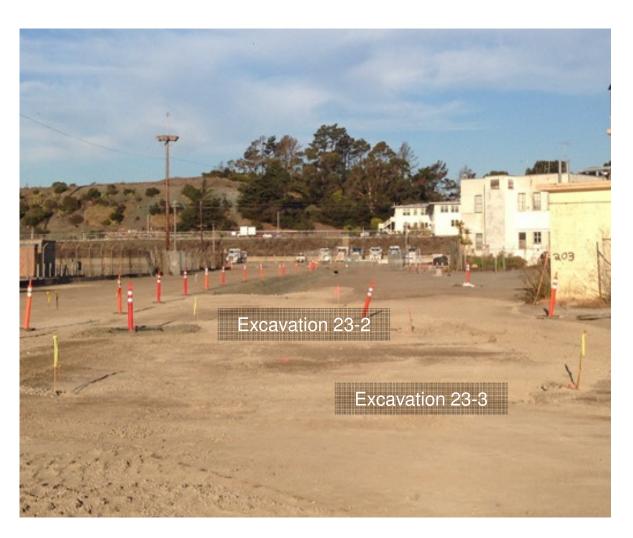
RU-C4 Summary (23-2, and 23-3)

- Excavations 23-2 and 23-3 were excavated by others
- Confirmation samples were collected insitu
- elevated organic lead (RG = 0.5 mg/kg) results in two of the sidewalls and at the bottom (SW01-3'=0.58 mg/kg, SW04-3' = 0.74 mg/kg; B01-6' = 0.54 mg/kg). Overexcavation underway
- 23-3 sample results met RGs

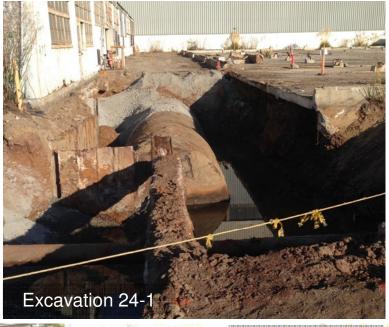
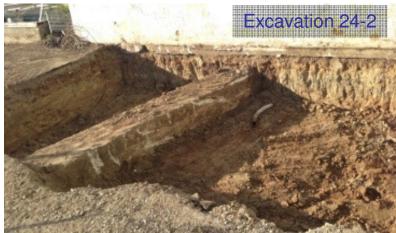
RU-C4 Summary (cont'd) (24-1 and 24-2)

- 24-1 and 24-2 were excavated and sampled in January
- 24-1 contains UST S-215
- Confirmation sample results had exceedences of various metals (arsenic, manganese, organic lead) => over-excavations of each sidewall (except the one that abuts Building 271) and the bottom were conducted. Sample results pending
- 24-2 samples met RGs with the exception of the bottom sample which exceeded manganese RG (1,620 mg/kg; RG is 1,431 mg/kg)

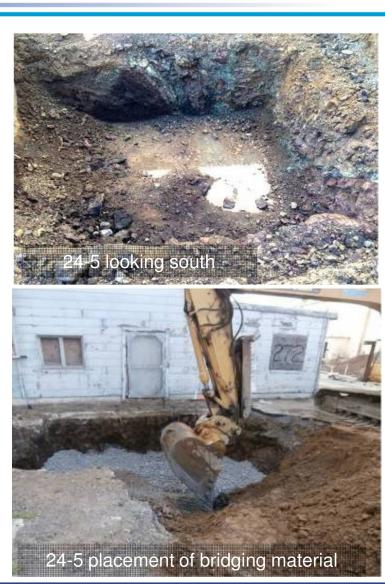
RU-C4 Summary (cont'd) (24-5)

- Excavation 24-5: A "Tier 2" excavation. Excavation complete. Bedrock encountered, sampled, and no further excavation conducted
- 24-5 was backfilled on November 26 and 27 to facilitate access to neighboring excavations

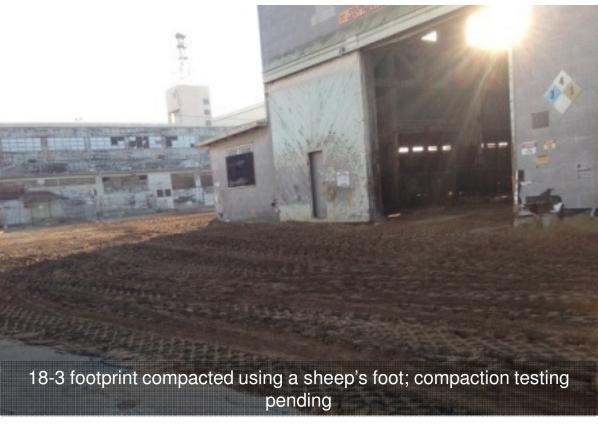
Building 241 Summary (18-1, 18-2, 18-3, and 18-4)

• Excavations18-1, 18-2, 18-3, and 18-4 - Final compaction and grading is underway.

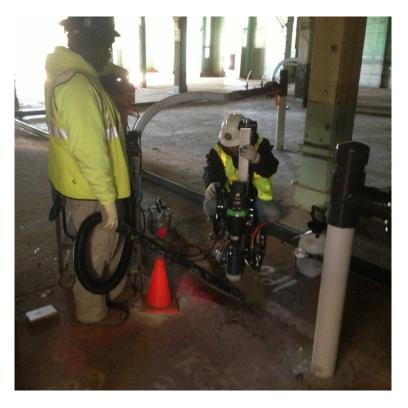
Injection point concrete coring in Building 272

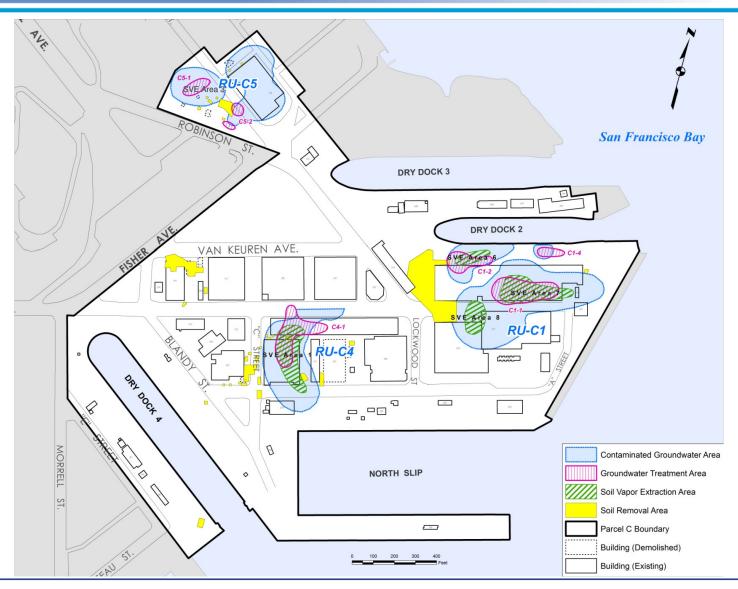
Parcel C SVE System Locations

- All well head manifolds have been constructed and installed for all four systems (SVE Areas 1, 3, 6/7, and 8)
- Concrete pads and SVE skid systems have been placed at three of the four locations
- •SVE System Startup testing ("shake-down") was successfully completed at RU-C4 (SVE 1) on January 22, 2014
- Baseline sampling has been completed at all sites

- Installation of piping as well as skid systems
- Placement of concrete pads
- System startup testing at the remaining three locations (some pending completion of excavations, compaction, and grading)
